**MONTICELLO NUCLEAR GENERATING PLANT**  
Docket No. 50-263 License No. DPR-22

**LER 98-004**

**Manual Scram Inserted Following Pressure Transient**  
**Closes Air Ejector Suction Isolation Valves and Trips Offgas Recombiners**

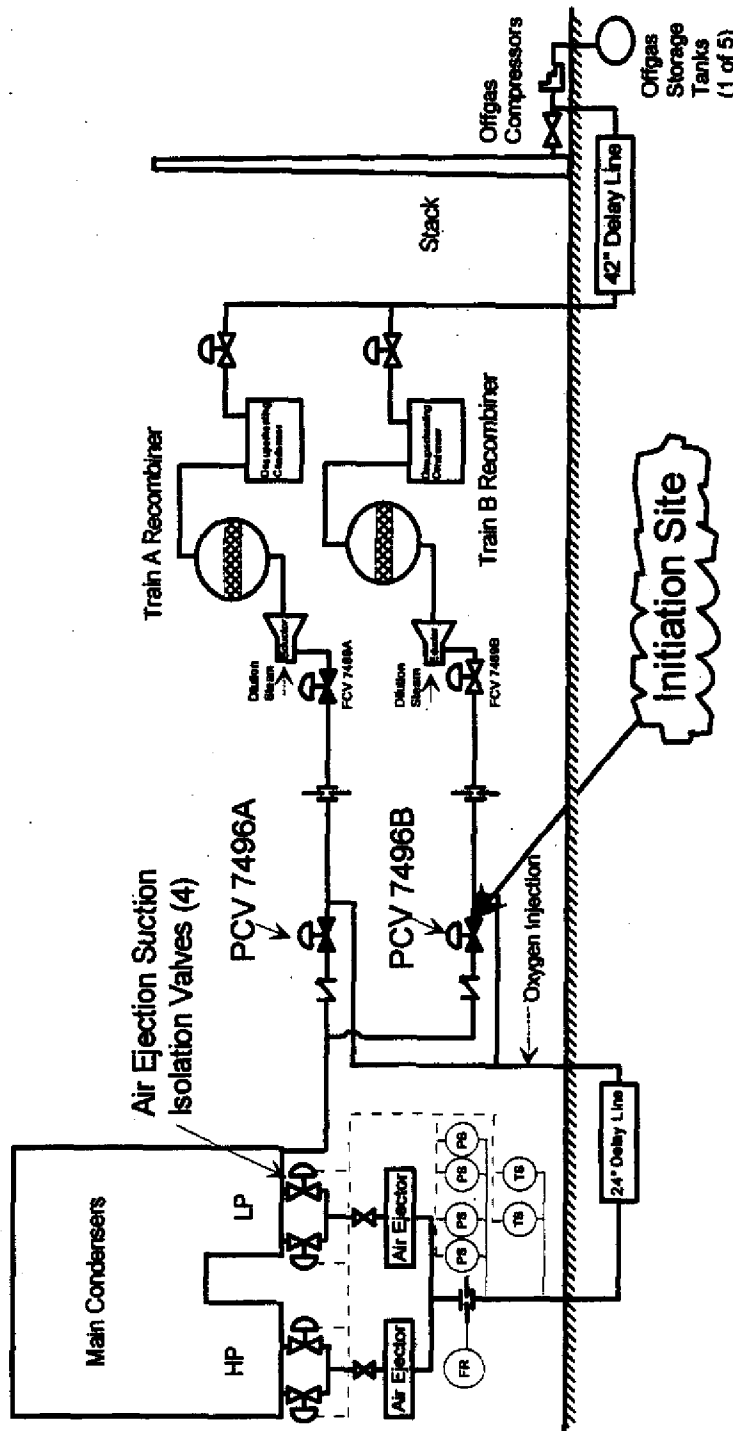
## Simplified Drawing of the Offgas System

The air ejector suction isolation valves are located between the main condenser and the air ejectors (See attached figure). The offgas recombiners are located downstream of the air ejectors and function to recombine hydrogen and oxygen gases.

Seat leakage on PCV-7496B was determined to be the cause of the event. The pressure on the high pressure side of the seat was between 12 to 13.5 psia with 1 to 2 psia on the low pressure side. It is believed that around September 2, 1998, the seat leakage on PCV-7496B self-ignited causing a stable bum of hydrogen and oxygen on the low pressure side of the valve seat. Hydrogen and oxygen gases are known to self-ignite when rapidly expanded. This hydrogen/oxygen bum caused the valve body to heat and the paint on the exterior of the valve body to release odors which were noted by operations personnel. Ventilation pressure differences caused the odors to travel through floor drains to the recombiner pump room which is regularly inspected by operations personnel.

The temperature of a section of the valve in contact with gases on the upstream side of the valve seat eventually reached the spontaneous ignition temperature for hydrogen and oxygen gases. At 0509, a rapid recombination of hydrogen and oxygen gases occurred, causing an extremely short duration pressure transient. The pressure transient caused instrumentation: 1) to trip both offgas recombiners and 2) to initiate an air ejector isolation.

The leaking valve seat on PCV-7496B was reworked as well as the similar valve in the redundant train.

Temporary instrumentation was added to measure the temperature of the valve body of PCV-7496A and B during power operations and record system pressure. An alarm was added in the control room to alert operators of temperature increases.
